Test Report 21-295
26 December 2001

**ELECTROMAGNETIC INTERFERENCE
TEST REPORT
FOR THE
Capstone Turbine Corporation
Micro Turbine Model: 330**

PREPARED FOR
Capstone Turbine Corporation
21211 Nordoff St.
Chatsworth, CA 91311

PREPARED BY
Nemko EESI Incorporated
9604 Variel Avenue
Chatsworth, California 91311

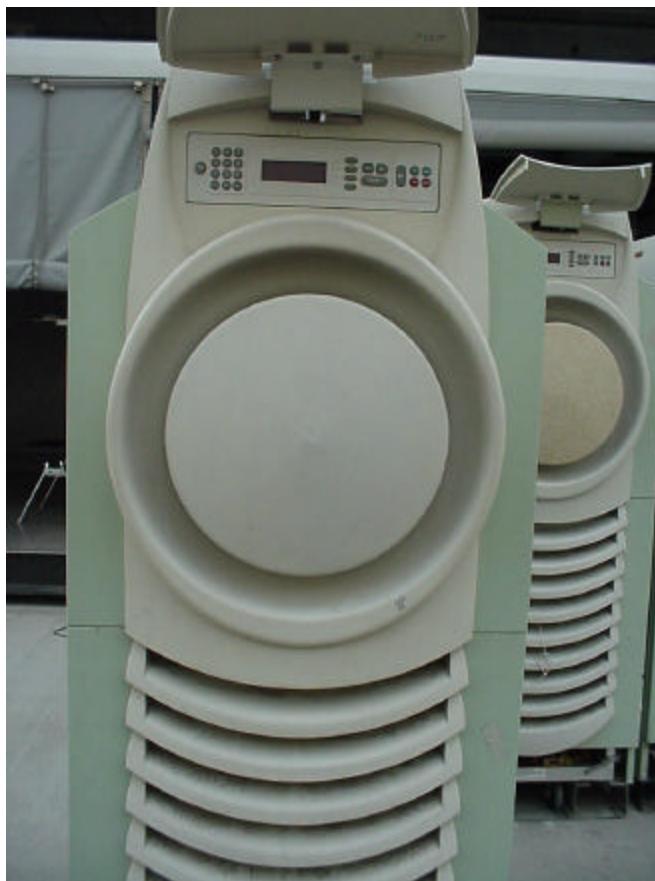
1.3 UUT Photograph

Micro Turbine Model: 330
